Maintenance and Service Instruction

This instruction is valid for all LPQ pump models shown on page 2

Valid for all pumps in sizes: LPQ 100/110/ 125/140; Rotor diameter and generation: L1/N1/P1/J1

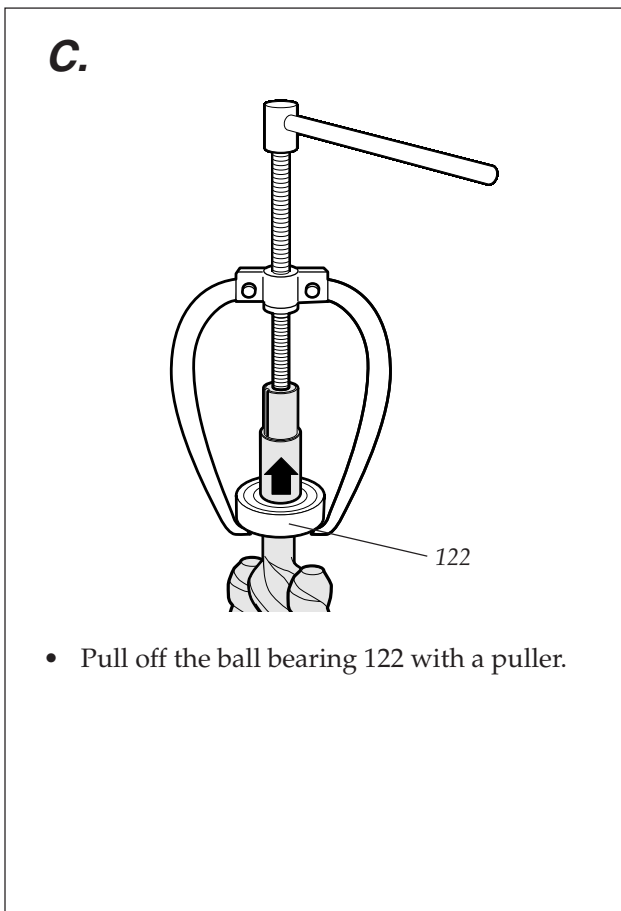
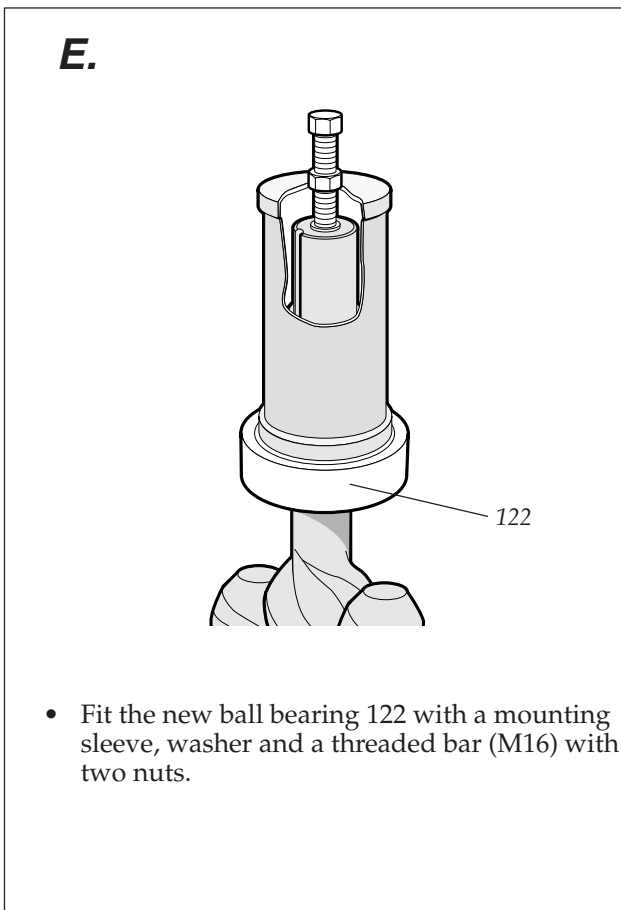
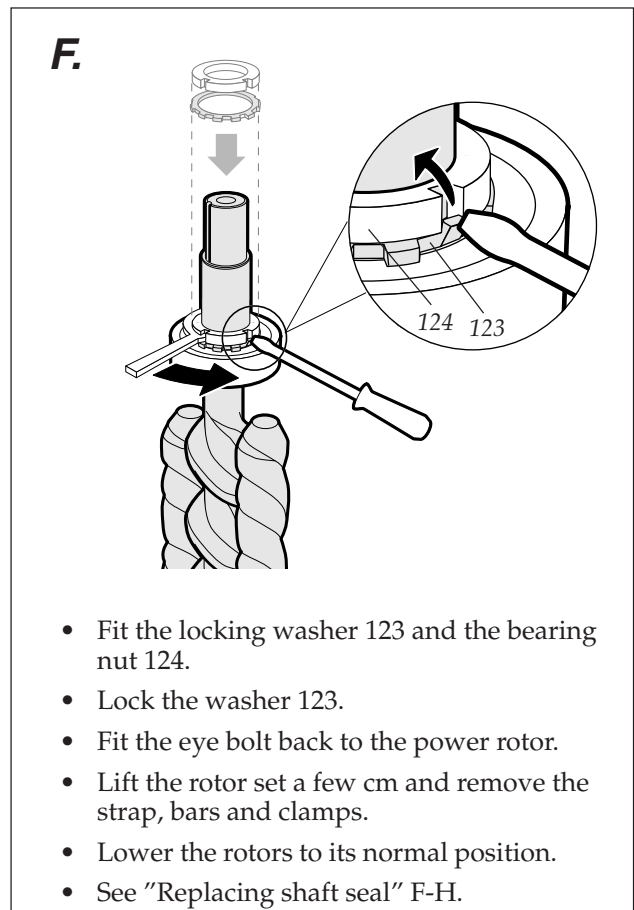
Inspection of rotors and replacing ball bearing

Internal clearances in the pump, which are vital for its proper function, may have been affected by wear. Acceptable wear can be determined only by experience of the actual application. As a rule of thumb the following max clearance values may apply:

- Between rotor and bores or bushings: 0.2 mm
- Between rotor flanks: 0.4 mm

For light duties (low pressure, medium viscosity) even bigger clearances may be acceptable but for low visc./high pressure duties the limit will be lower. Also check if there are major scratches on these parts.

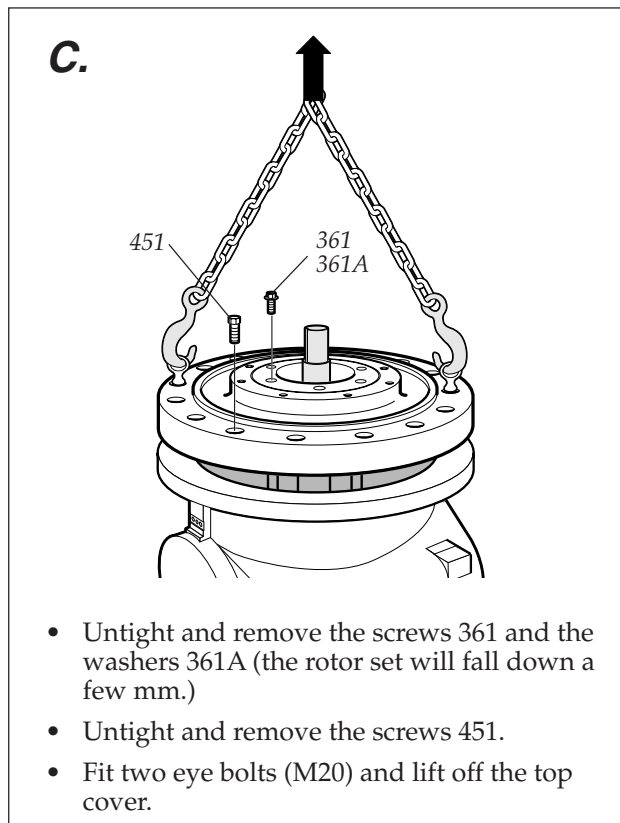
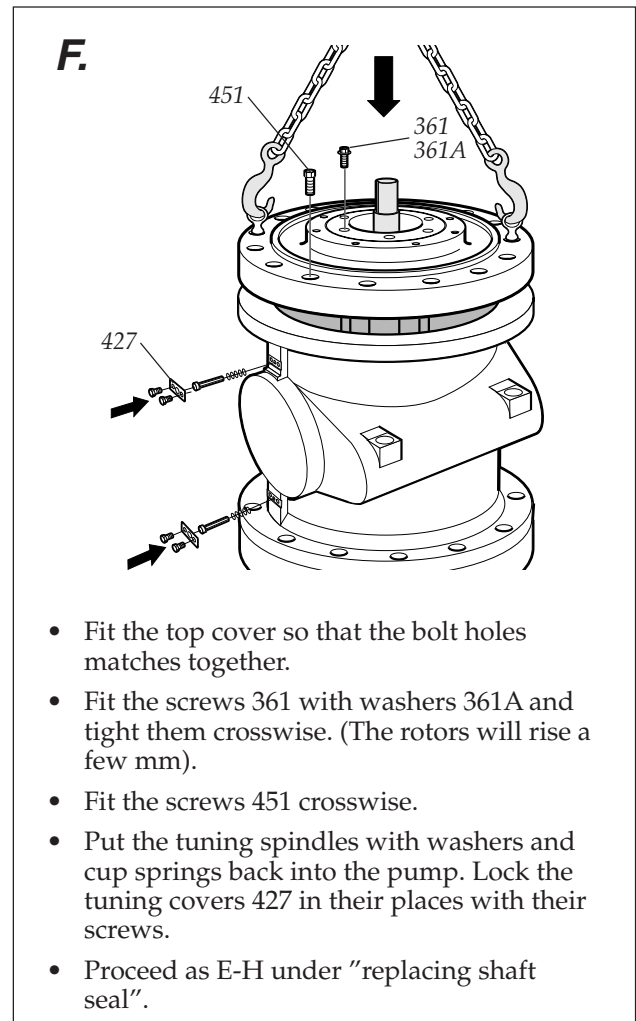
Replacing pump element G090
